CPS FACILITY ASSESSMENT MANUAL

2025 – 2026

ARCHITECTURAL ASSESSMENT

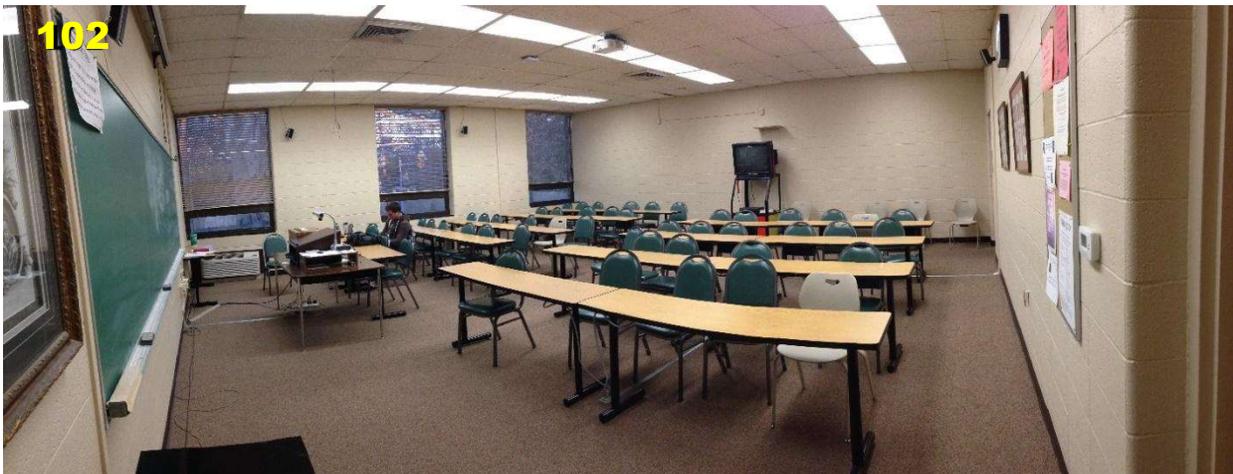
In addition to the extensive photography collected per each assessment, every one of the district's unique 20,000 classrooms will also require a specific photograph taken in the following manner:

- 1) Each classroom photograph will be panoramic (see example below) captured from one of the four corners of classroom.
- 2) The classroom number (as displayed at the school) must be recorded as a caption in the upper-left hand corner of the image.

Example: Panoramic Photograph of a typical Classroom
